# Manhole Inspection Summary

## Manhole # S17WW1007MH

**Location** Address: **CLYBURN AVE**

Cross Street: **NORTHERN PKWY**

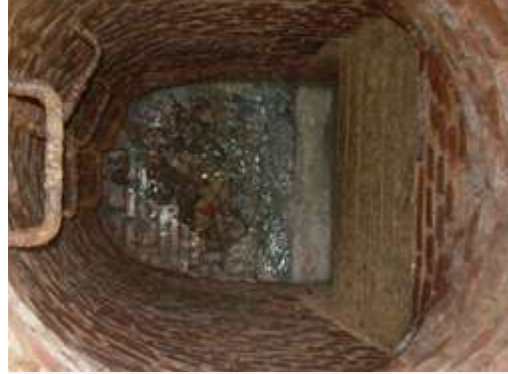
Top View

Corroded steps. Evidence of surcharge - Bench debris.

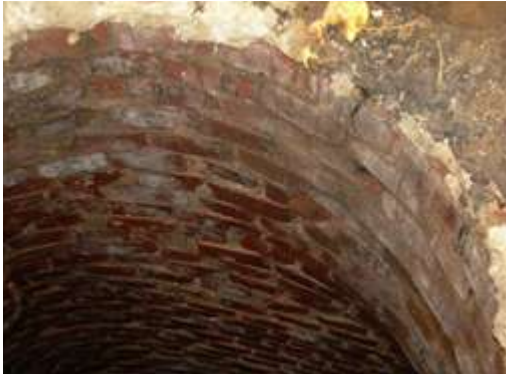
Defect

Frame leaks. Frame offset. Corbel deterioration and infiltration. Barrel infiltration.

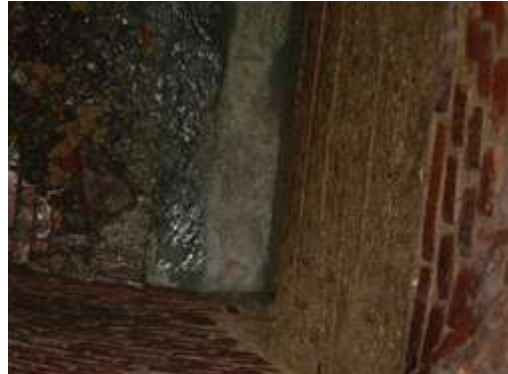
Defect

Barrel infiltration.

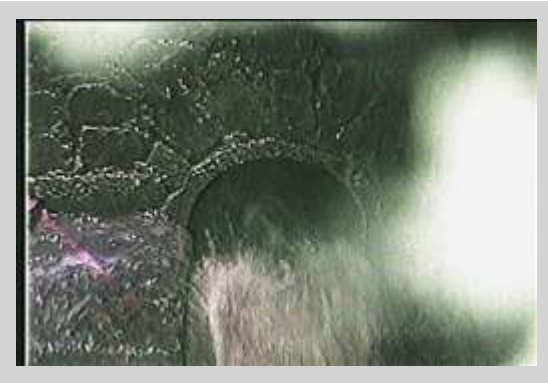
### 10 in. Circular Gravity Sewer Pipe Out @ 12 O'Clock

Barrel deterioration and infiltration.

Infiltration: **None** Pipe Seal Cond: **Cracked**

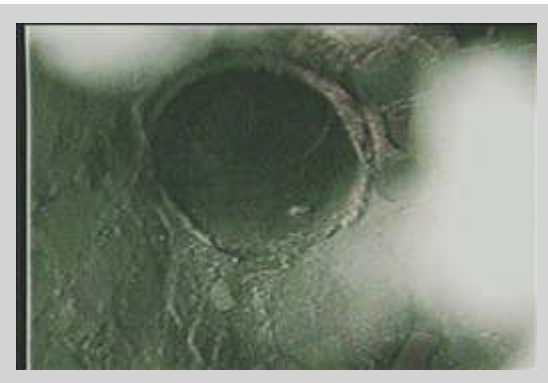
### 10 in. Circular Gravity Sewer Pipe In @ 6 O'Clock

Infiltration: **None** Pipe Seal Cond: **Cracked**
